TECHNICAL REPORT NO. 184-1

**Spillway Tailwater Channel Erosion at  
Little Goose Dam  
Snake River, Washington**

**SPONSORED BY  
U. S. ARMY CORPS OF ENGINEERS  
WALLA WALLA**

**December, 1983**

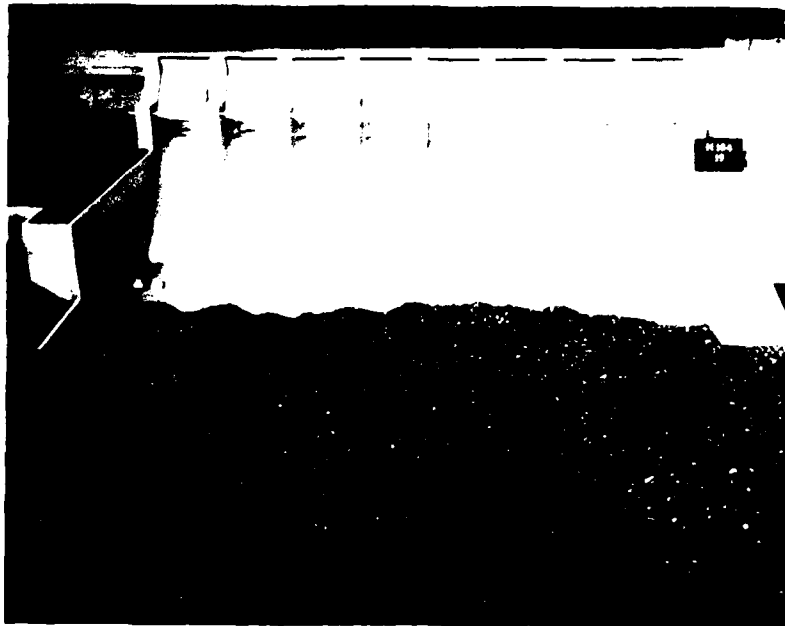
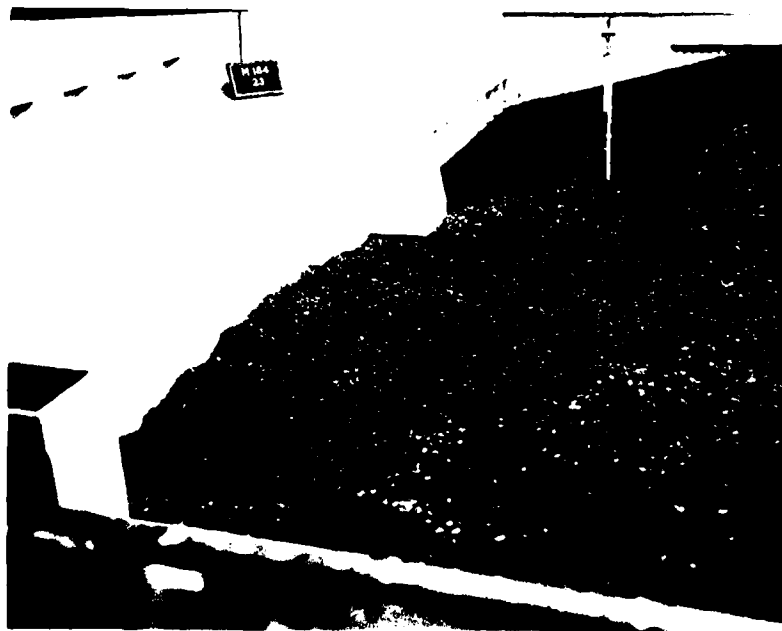
Photograph 9

Flow conditions same as with 120,000 cfs. Approximately 5 feet of erosion at downstream face of bucket at bays 1 and 2, along right training wall, and along fish dike retaining wall. No increase of undercutting of left wall detected.

Channel topography after river discharge 160,000 cfs  
with spillway discharge 96,600 cfs

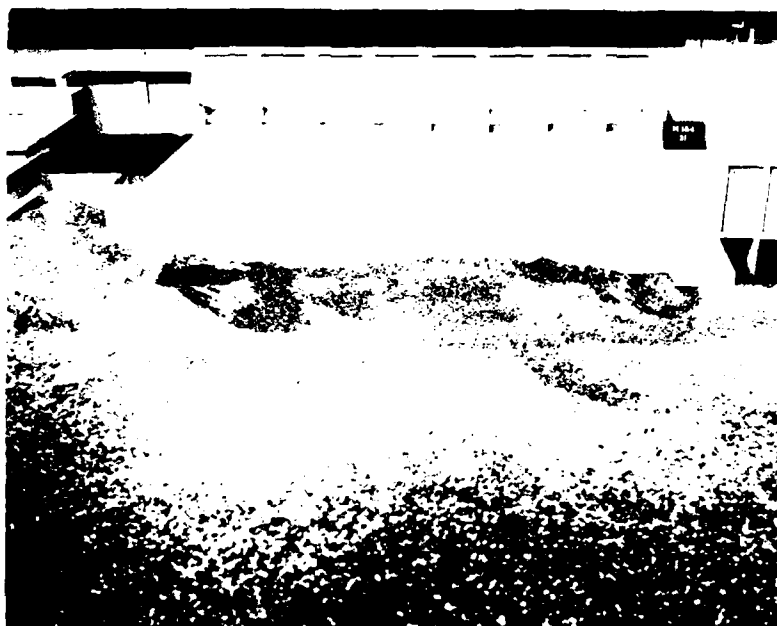
Photograph 13

Stronger skimming flow (bays 2 to 7) and roller bucket action (bays 1 and 8). Additional 5 feet of erosion along right wall. Undercutting of fish dike retaining wall extended to full length of wall (bottom of wall at approximately elevation 498 feet). Minor erosion along face of bucket at bays 1 and 2. Rock deposited against face of bucket at bay 4. No rock deposited in the bucket.

Channel topography after discharge 200,000 cfs  
with spillway discharge 133,000 cfs

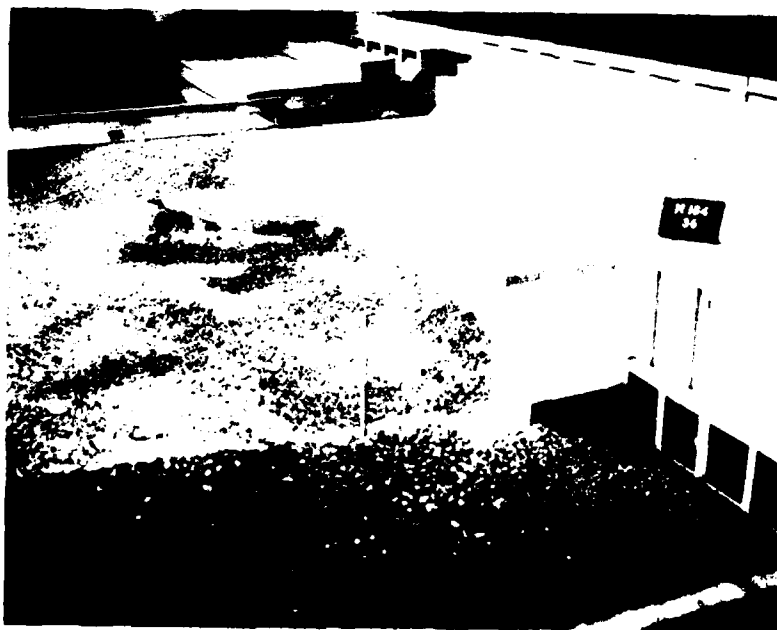
Photograph 15

Channel topography after river discharge 200,000 cfs  
with spillway discharge 133,000 cfs

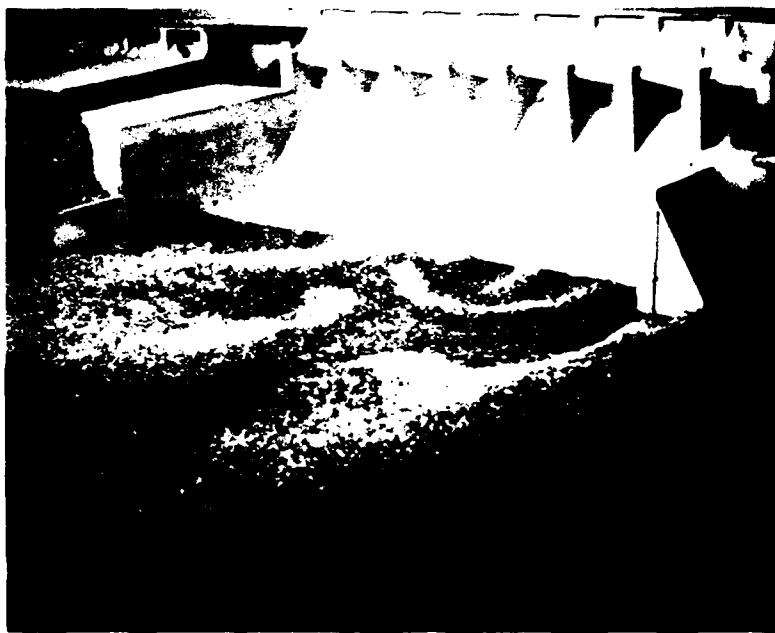
Photograph 26

Flow conditions same as with 250,000 cfs. Additional erosion downstream from bay 7. Additional deposition against bucket at bay 6. No additional erosion at the walls. Rock carried into bucket in bays 4 to 6 and agitated until moved to end bays and washed out of the bucket. Only small amount of rock remained in bucket at end of test.

Channel topography after river discharge 280,000 cfs  
with spillway discharge 214,000 cfs

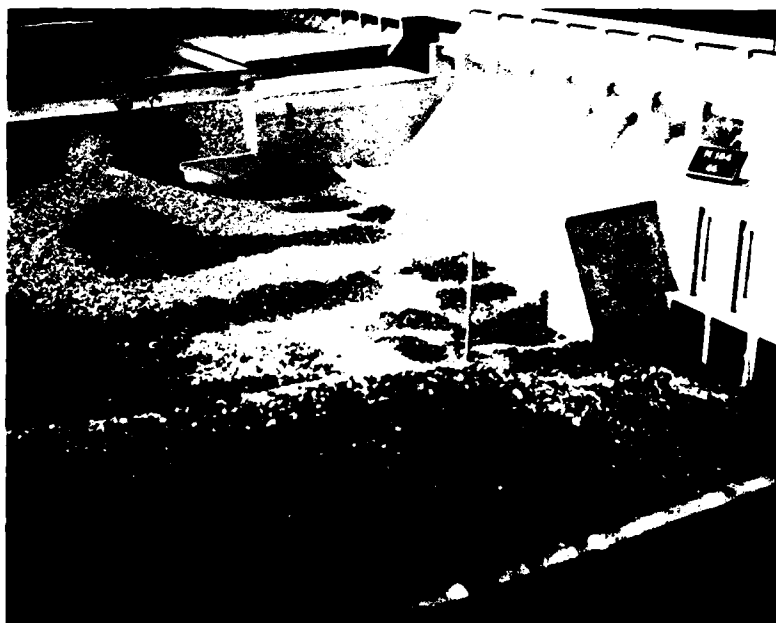
Photograph 33

Flow from bays 2 to 5 alternated between skimming and plunging. Surface boils occurred near both training walls. Less rock movement in bucket than with 280,000 cfs. Loose rock and 5 feet of bed material eroded at face of bucket at bay 4. Fish dike erosion increased with material deposited downstream from retaining wall. No additional erosion of hole downstream from left wall or along right wall.

Channel topography after river discharge 300,000 cfs  
with spillway discharge 234,000 cfs

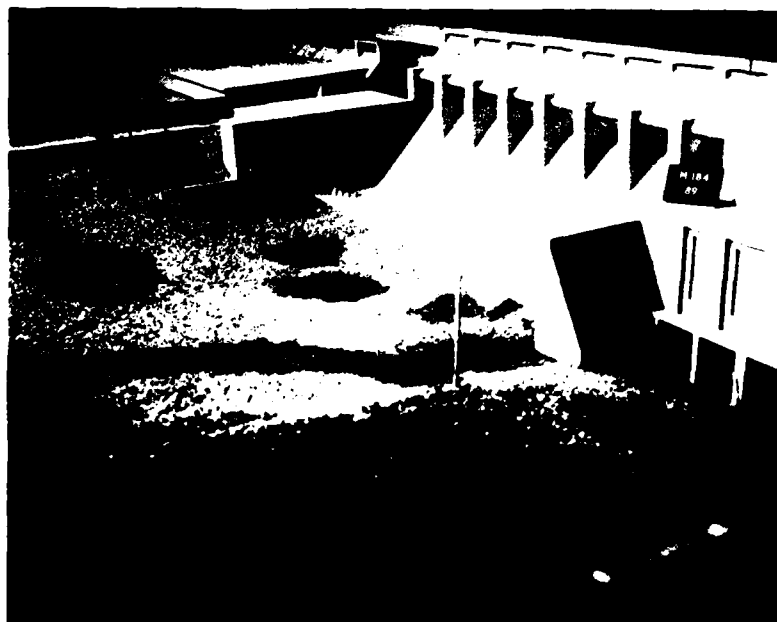
Photograph 48

Flow plunging in bays 1, 2, 7, and 8 and alternately plunging and skimming in bays 3 to 6. Some rock swept into center of bucket and out at end bays. Additional erosion downstream from retaining wall and from fish dike. Large deposition berm formed 150 feet downstream from retaining wall. Small amount of loose rock deposited along right wall with 350,000 cfs swept downstream. Minor erosion along face of bucket at bays 2 to 8.

Channel topography after river discharge 400,000 cfs  
with spillway discharge 334,000 cfs
